# KAMPALA CITY SANITATION PROFILE

## Increasing Access to Improved Sanitation in Kampala Capital City

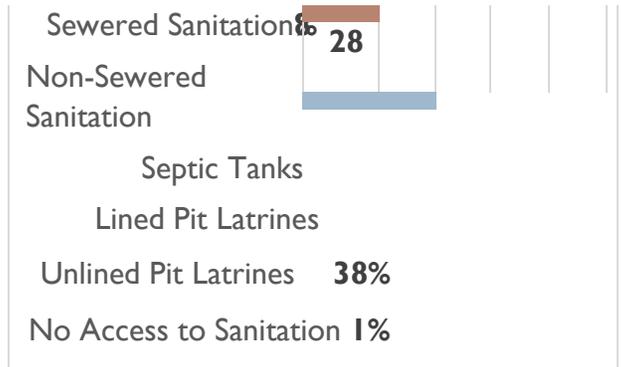
Figure 3: Sanitation Technologies in Kampala

The sanitation survey established that pit latrines are the predominant sanitation technology in Kampala at 66%. The majority of these are unlined pit latrines (38%) which pose significant risks to groundwater and environmental pollution. Most unlined pit latrines are situated in Kawempe whilst the least number of unlined pit latrines are found in Central Division.

Flush toilets to the sewer and septic tanks constitute 33% of the sanitation technologies in the City. In terms of population served, septic tanks, lined pit latrines and unlined pit latrines each cover 30% of the City’s population respectively. Only 8% of the population accesses the municipal sewer network services. A total of 1,506 properties equivalent to a population of 11,000, lacked sanitation facilities.

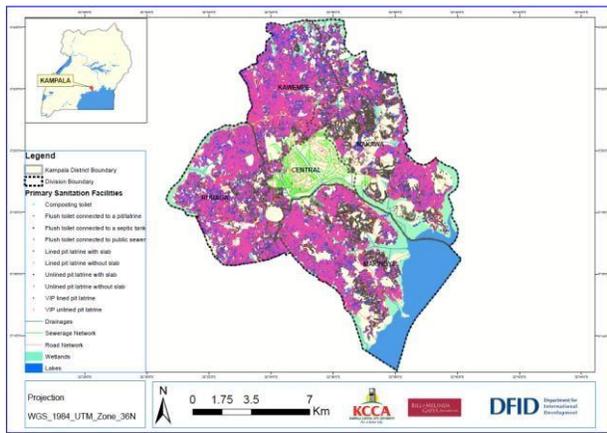
Figure 4: Mapping of On-site Sanitation in Kampala

The Mapping exercise shows that access to Sanitation Citywide is at 99%. This implies that 1% of the population have no access to a sanitation facility and practice Open Defecation sometimes referred to as flying toilets.

The mapping also shows that 50% of all the residential sanitation facilities in Kampala are shared. Each shared sanitation facility (toilet block) on average serves about 5 other households or 28 other people considering an

average household occupancy of 5. The highest percentage (59%) of shared sanitation facilities are located in Central division while the least (47%) are situated in Nakawa division.

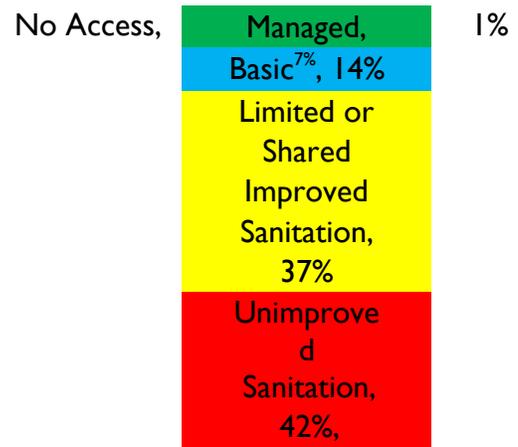
Figure 5: Sanitation Service Levels in Kampala

Safely managed sanitation refers to improved sanitation facilities that are not shared and whose waste is either; i) safely treated on-site, ii) temporarily stored and safely transported to treatment off-site or iii) transported by sewer to treatment off-site

- 7% of Kampala’s population accesses safely managed sanitation.

When the management of waste from improved sanitation facilities that are not shared is not safely managed, then people using those facilities are classified as having Basic sanitation.

- 14% of the population therefore, access basic sanitation.

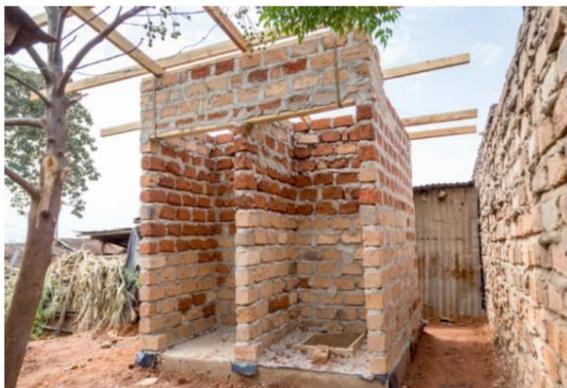
Figure 7: Lined facility under construction

- Lined sanitation facilities are the minimum standard for improved sanitation (KCCA, 2017).

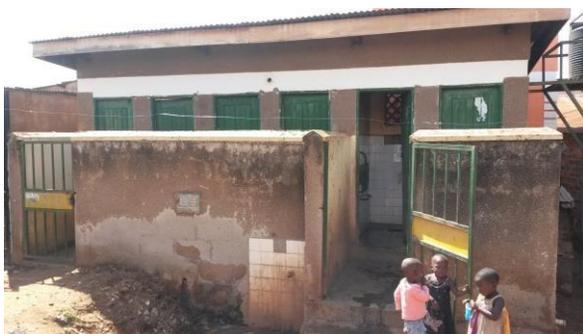
Figure 8: Community toilet in Kisenyi

- Limited sanitation refers to improved sanitation facilities that are shared with other households.
- 37% of the population in Kampala access limited sanitation.

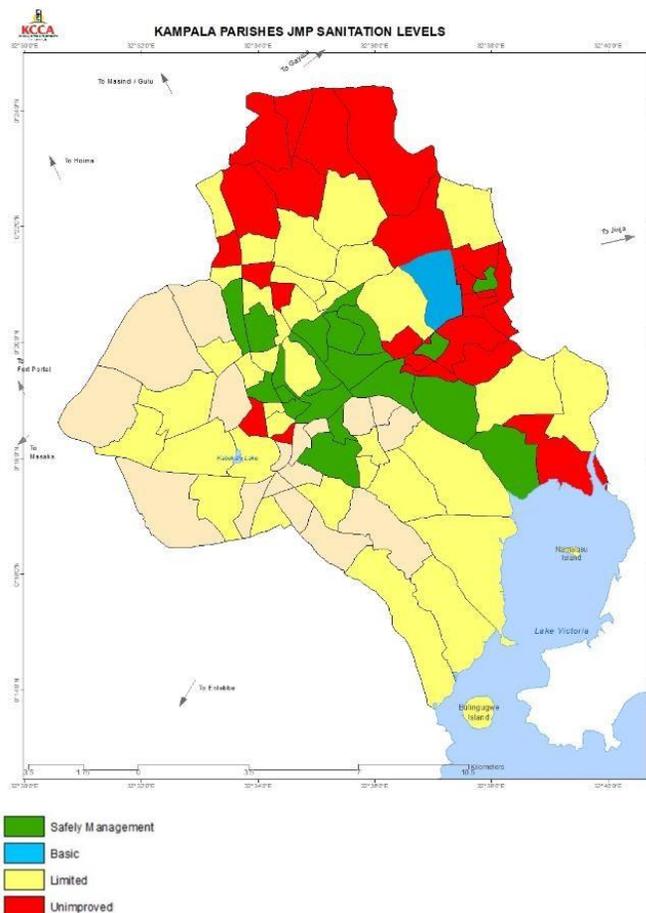
Map of Kampala Showing unimproved / improved sanitation parishes

- Unimproved sanitation refers to facilities that do not hygienically separate excreta from human contact e.g. unlined pit latrines, pit latrines without slabs, bucket latrines, pit latrines and septic tanks discharging into drains, e.t.c
- Unimproved sanitation is a major cause of surface and groundwater pollution that leads to the proliferation of sanitation related diseases.
- 42% of the population accesses unimproved sanitation.

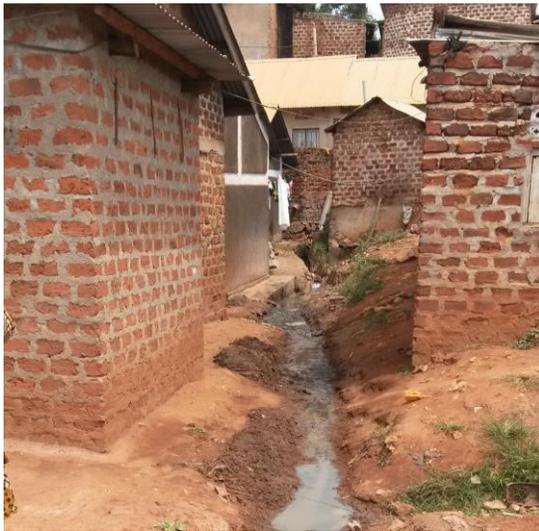
Figure 9: Toilet and Bathroom waste flowing into drains

- Solid waste is disposed of in pit latrines constraining emptying processes when the latrines fill.
- 2% of sanitation facilities (latrines and septic tanks) openly discharged fecal sludge to either a drain, ground or water body and thus contaminating the environment.

- Manual emptiers are still used by 2% of the population. These empty the waste into drains or the environment during rain events raising the risks
